(2008) - Sixth International Conference on Case
Histories in Geotechnical Engineering

Benefits of Case Based Instruction in Undergraduate Geotechnical Education

BENEFITS OF CASE BASED INSTRUCTION IN UNDERGRADUATE GEOTECHNICAL EDUCATION

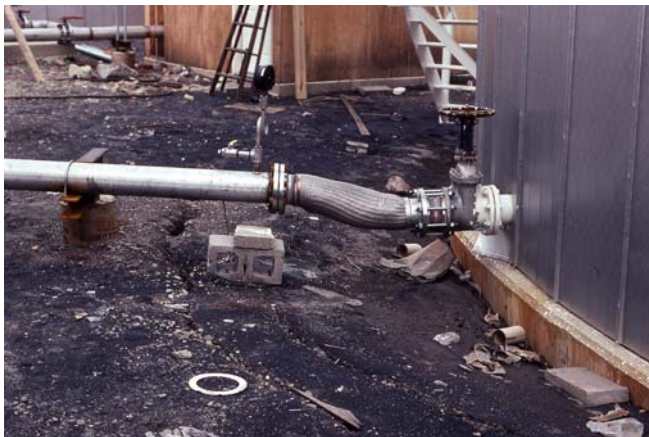
Fig. 8. Flexible connection indicates movement and ground failure

During integrity testing of the tanks, the owner noted that one of the tanks started to visibly tilt in a northerly direction as it was filled with water. There followed a panicked call to the geotechnical consultant who advised immediate unloading of the tanks and the execution of a level survey to establish the pattern and magnitude of the ground movement around the tanks. A maximum vertical settlement of 400mm (16 inches) was recorded in a sixteen-hour period – obviously indicating a bearing capacity failure in the underlying soils. Fig. 8 shows the failure in the ground and the downward movement of the flexible connection pipe that once stood at an elevation higher than the crown of the horizontal distribution pipe.
